# Case - study LV Fackfeeds

## Incident – Electric Shock from Disconnected Mains Cable (19 April 2018)

EEA H&S Workshop  
10-11 October 2018

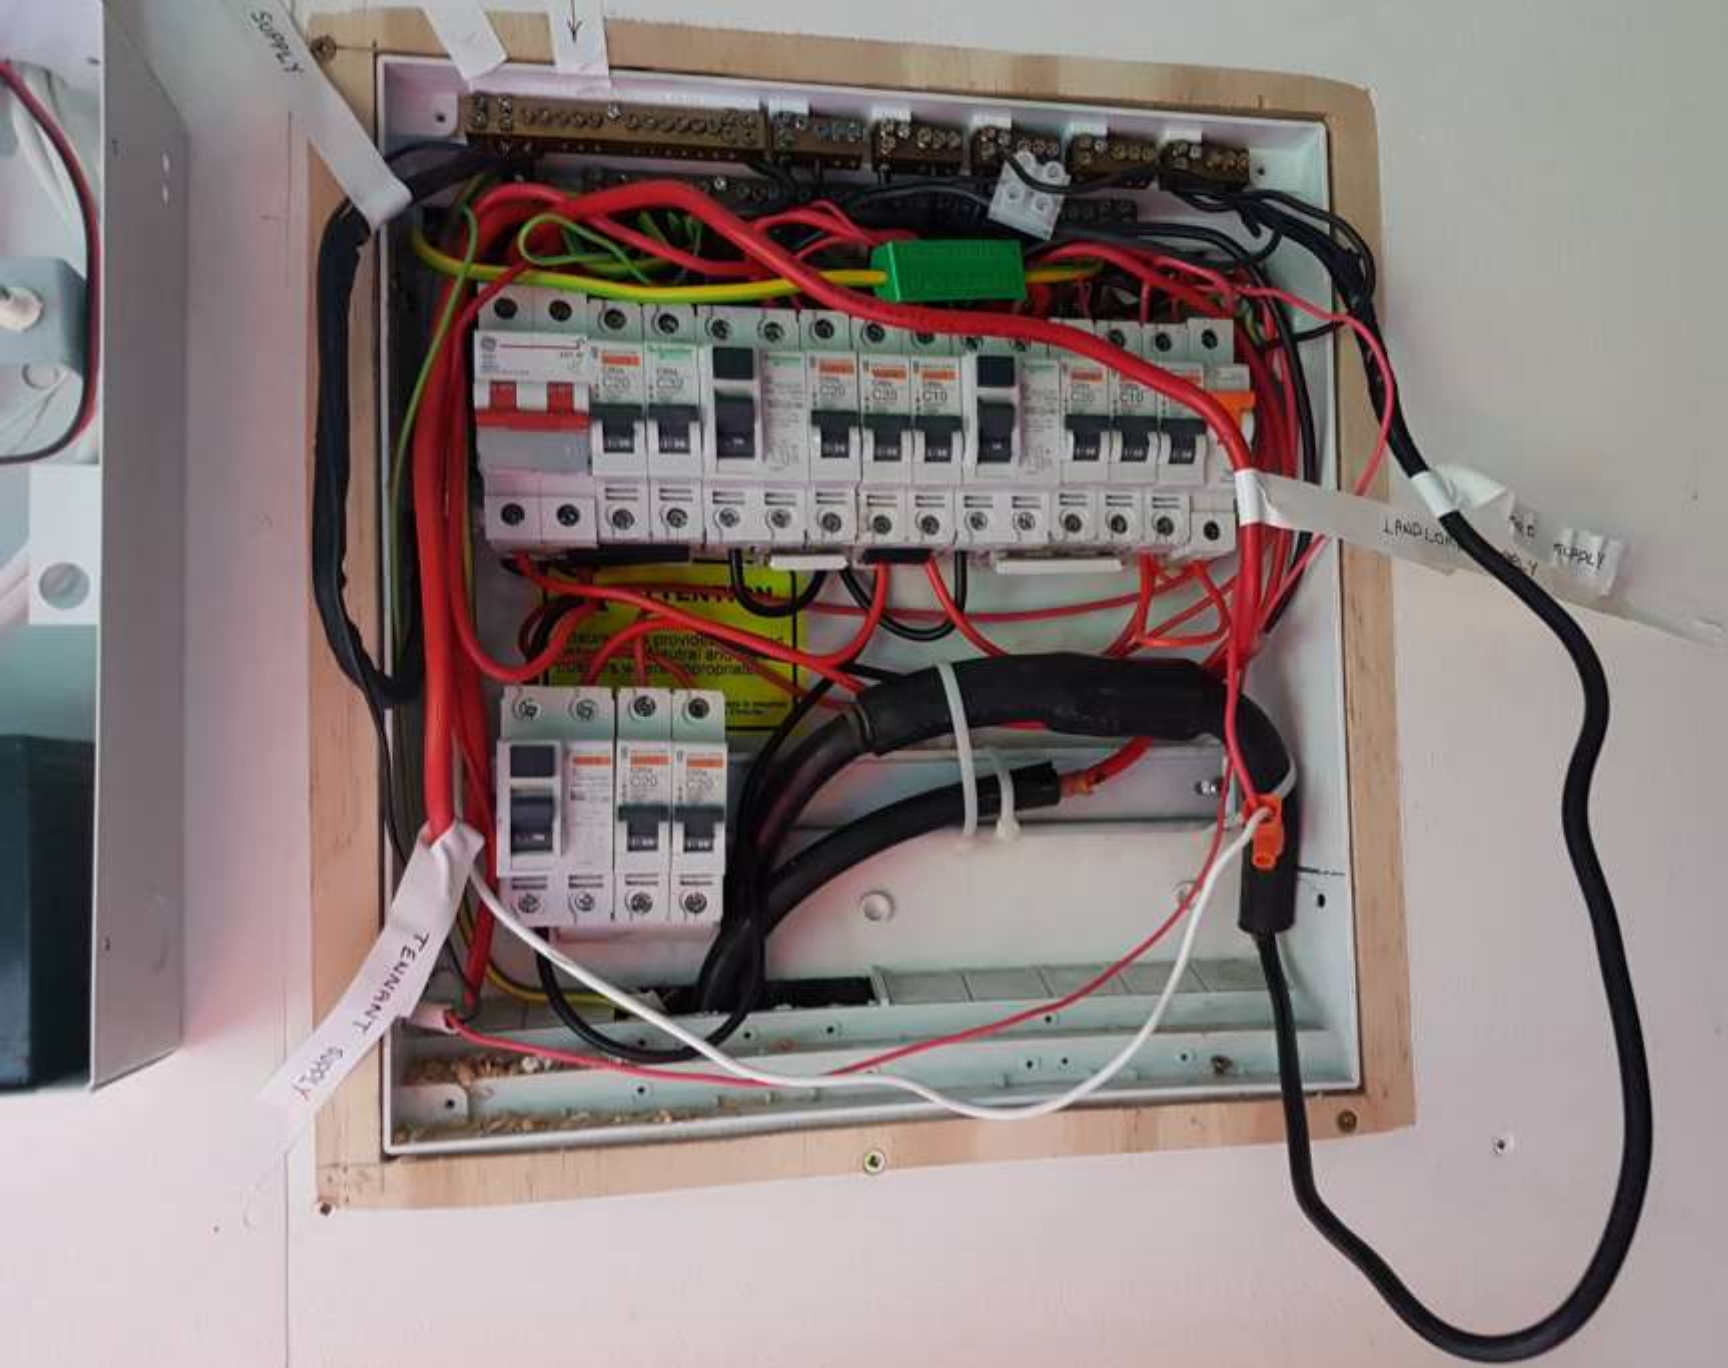
Two  
Supplies  
Labelling

1x From HOUSE  
1x STREET

→ WARNING - 2 Supplies to this sw Bd

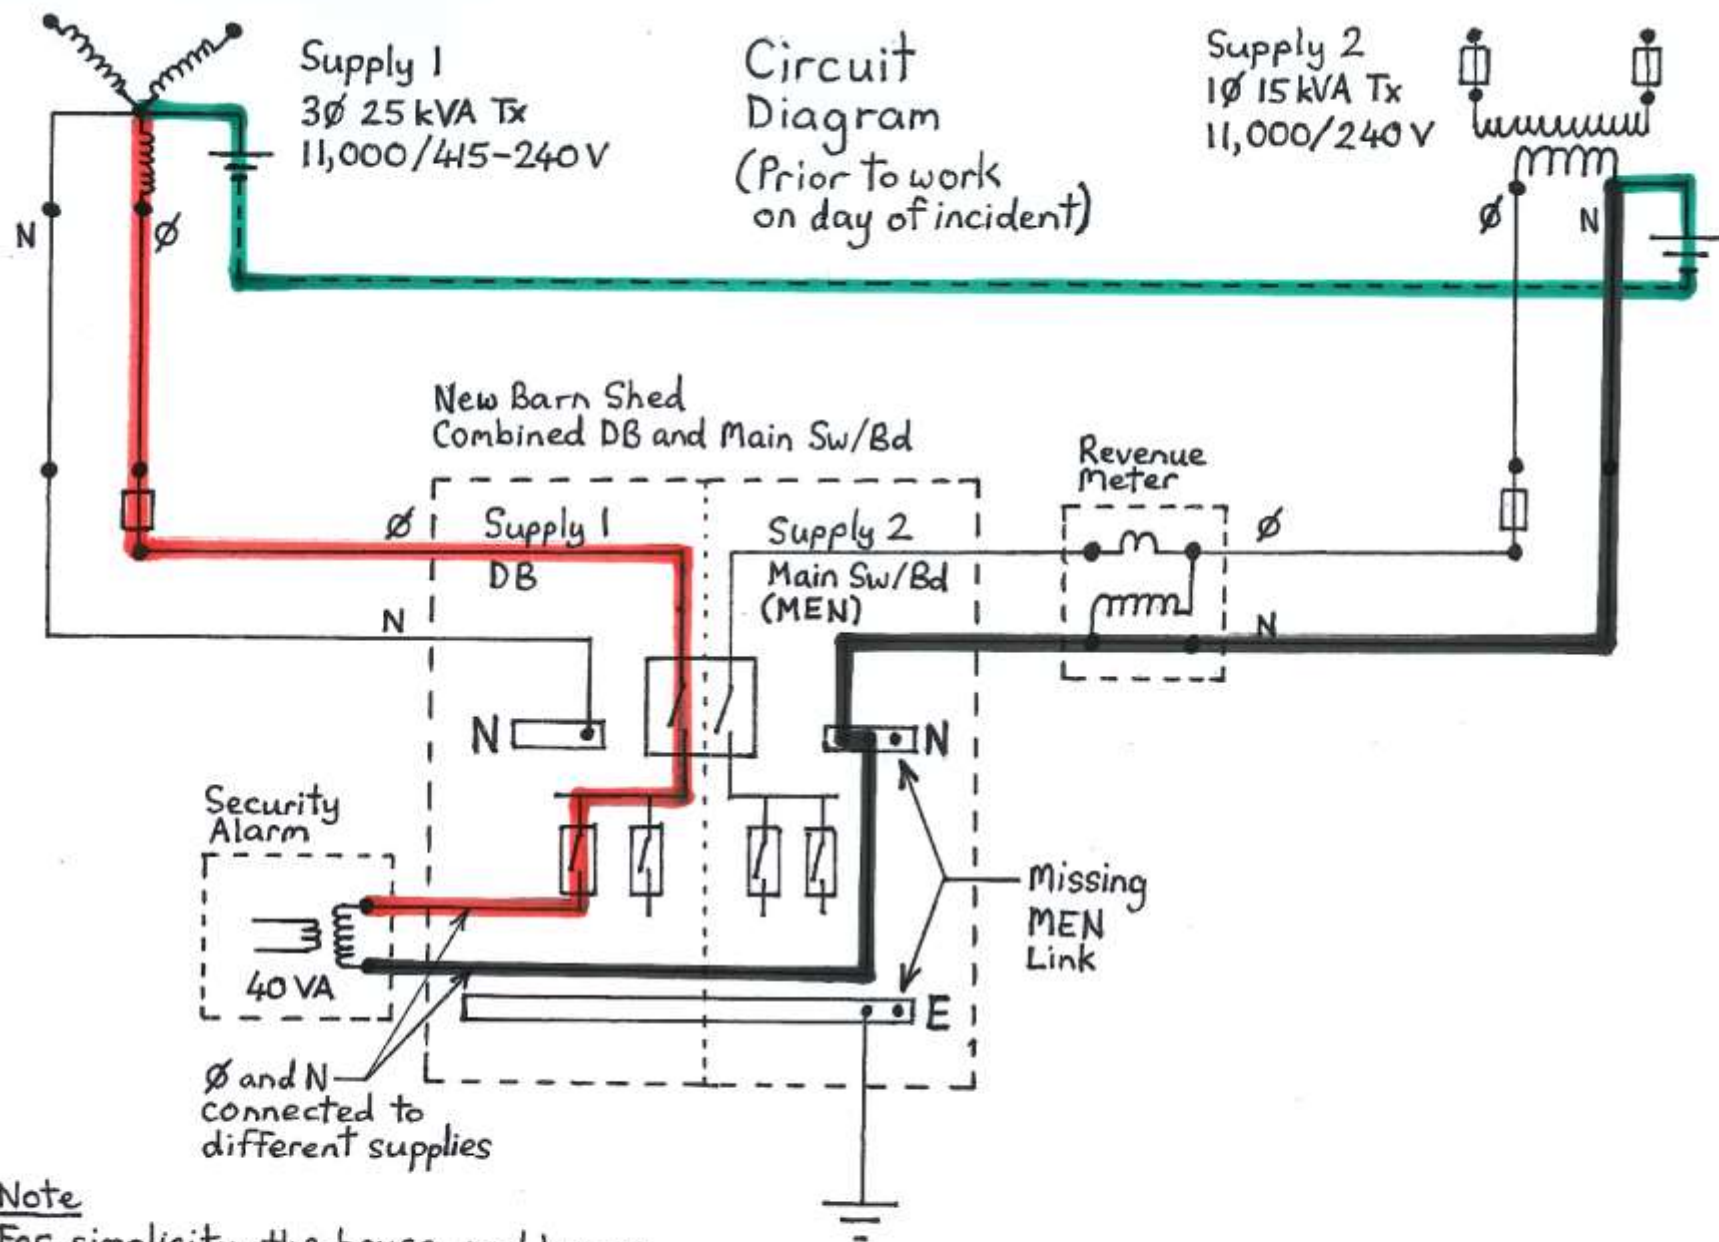
For simplicity, the house, pool house, and old barn shed switchboards are not shown.

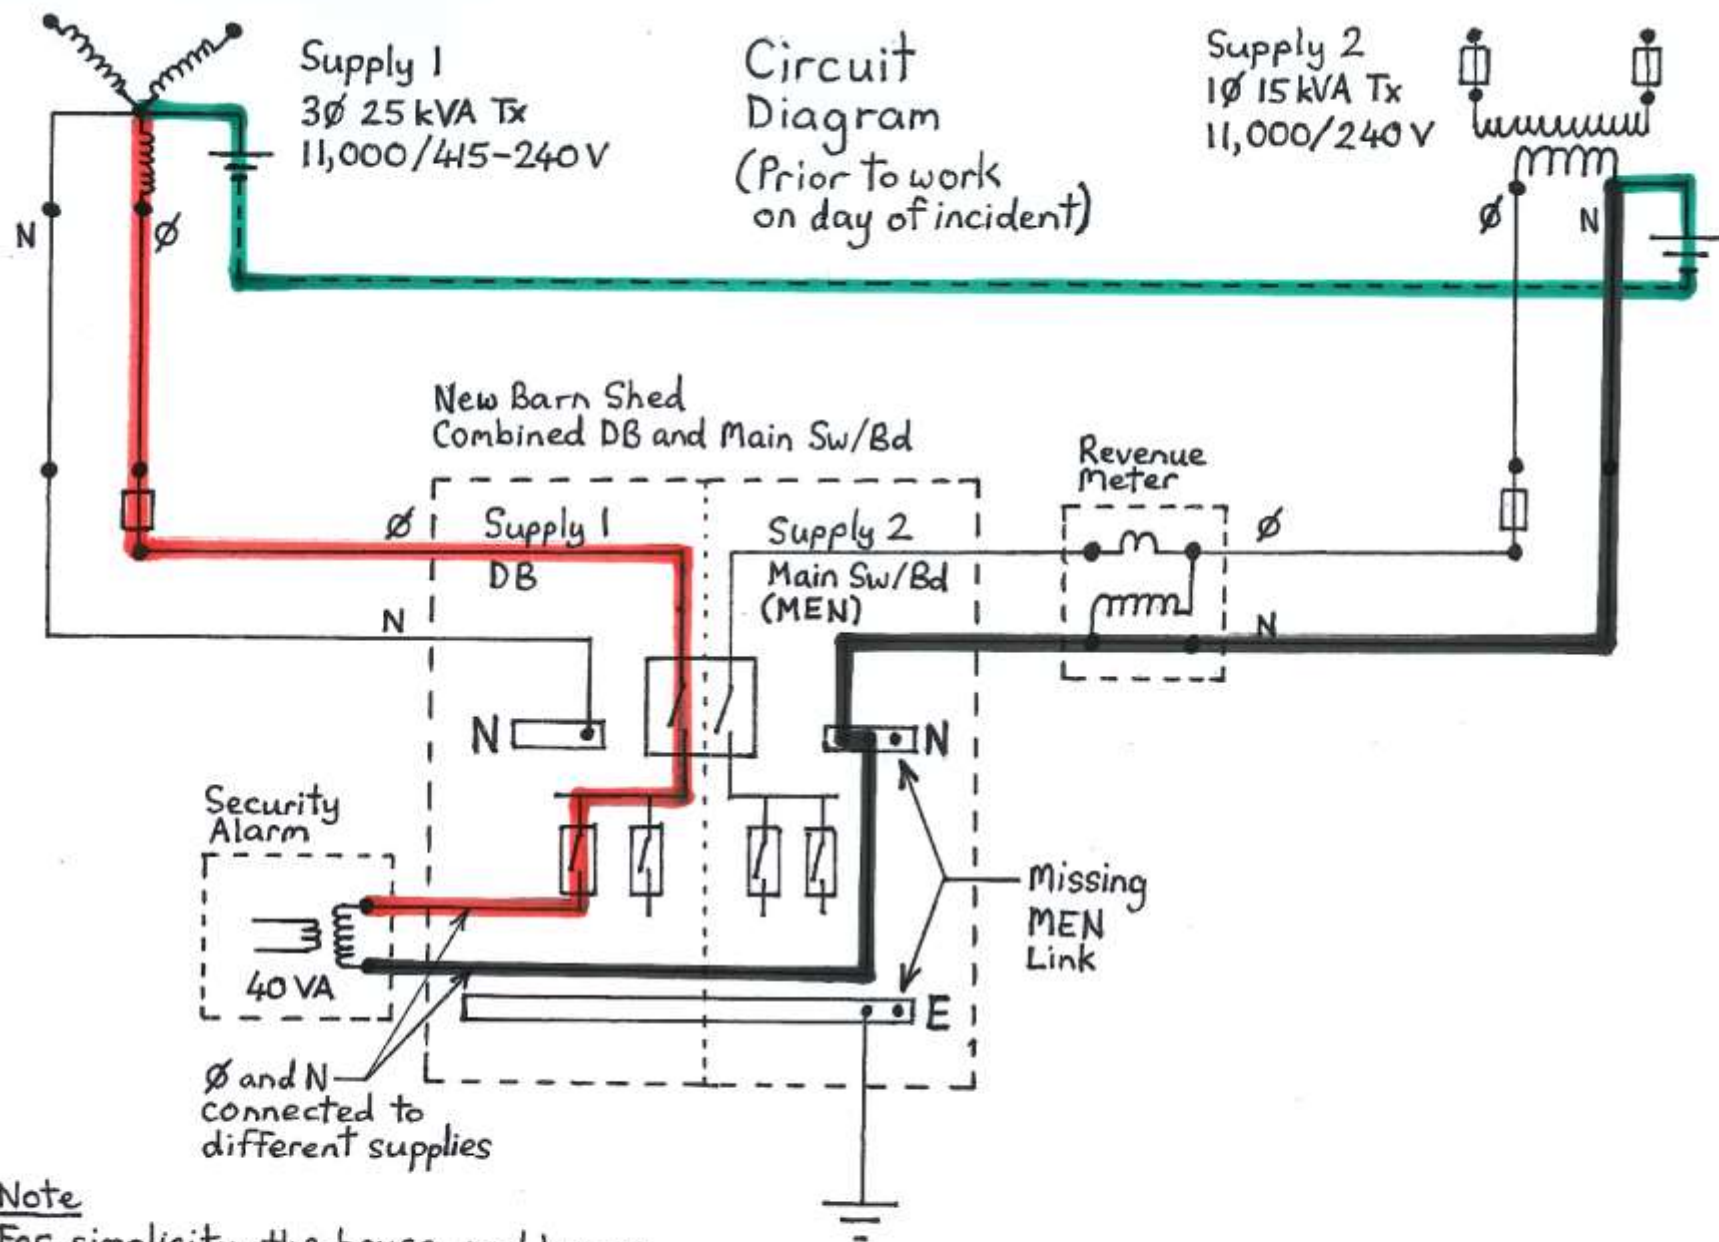
For simplicity, the house, pool house, and old barn shed switchboards are not shown.

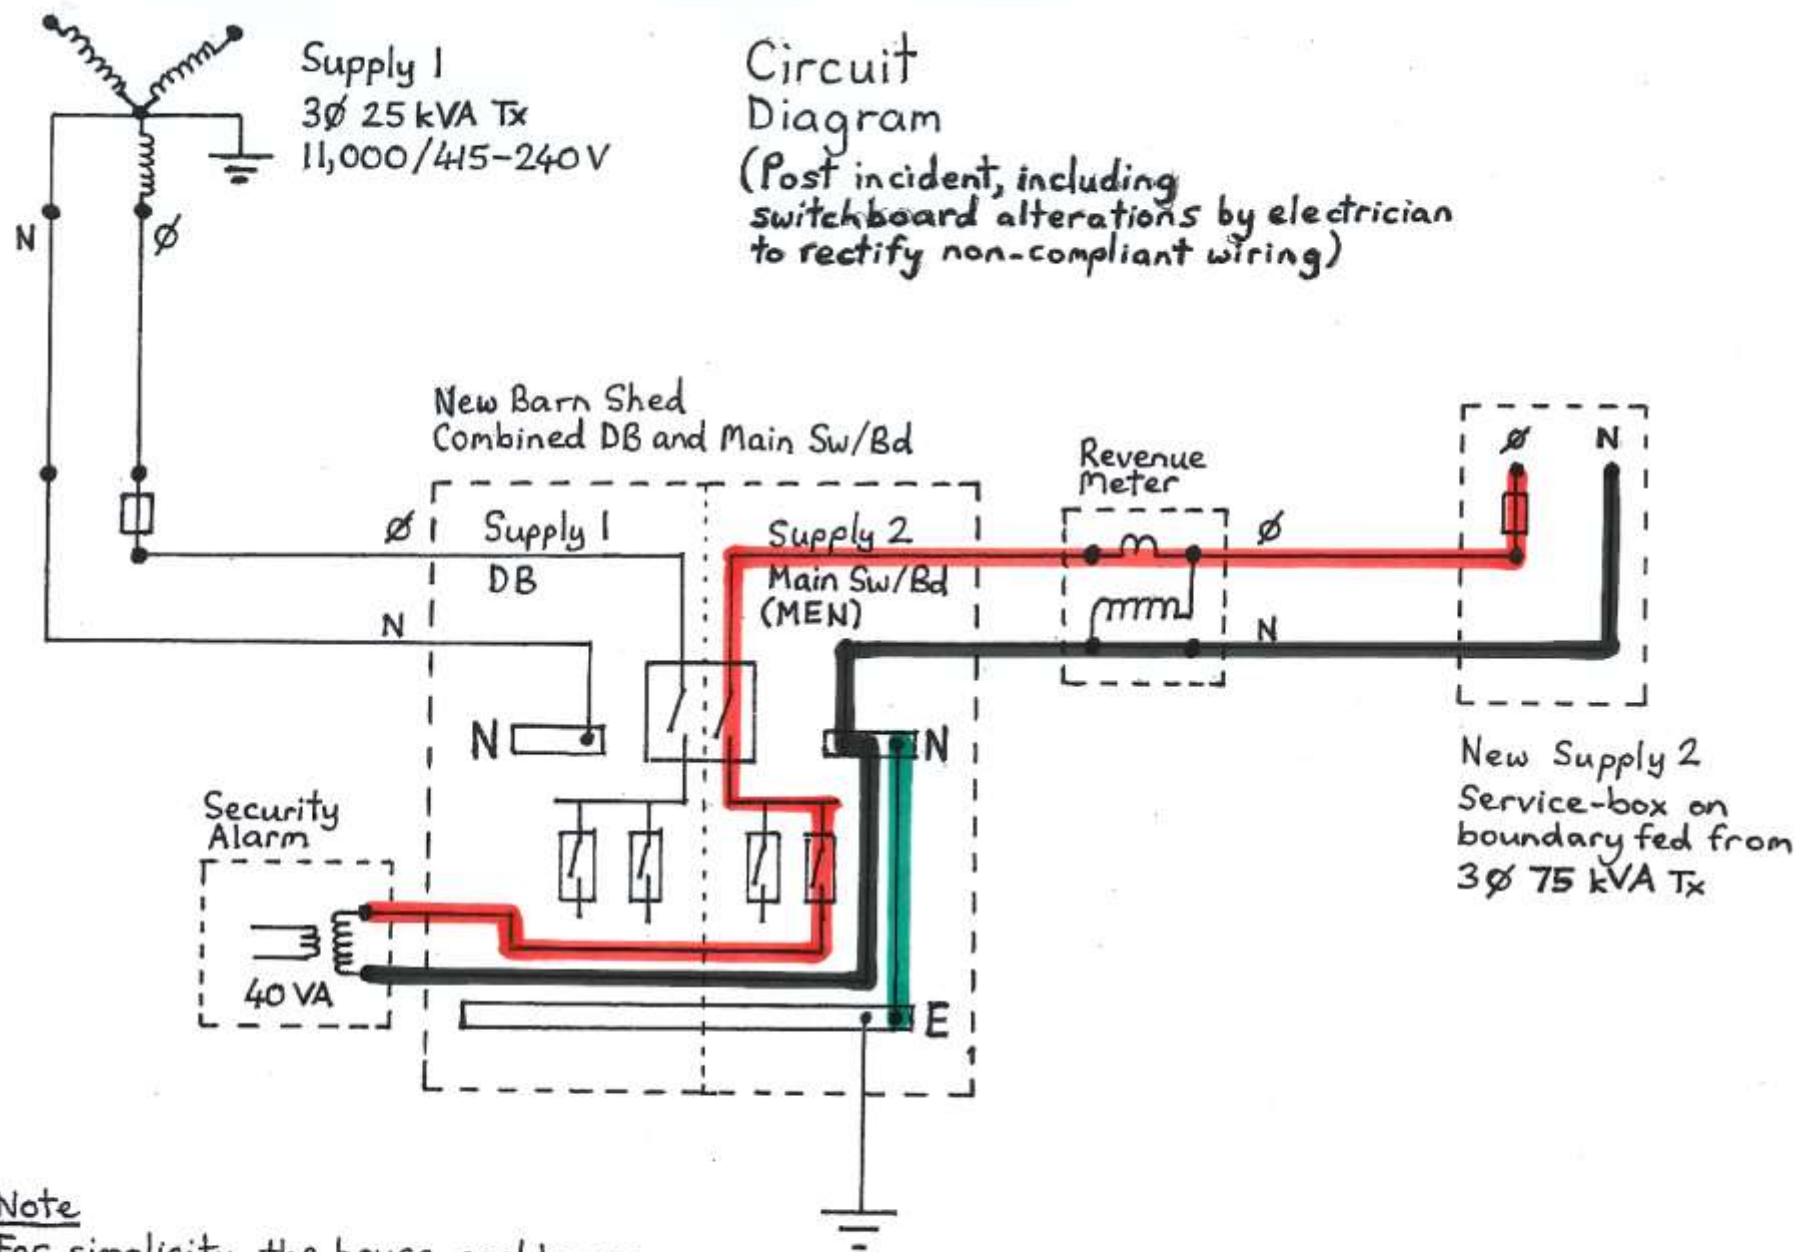
For simplicity, the house, pool house, and old barn shed switchboards are not shown.
